How do channels migrate uphill?

Observations from the Walnut Gulch Experimental Watershed

Mary Nichols and Mark Nearing

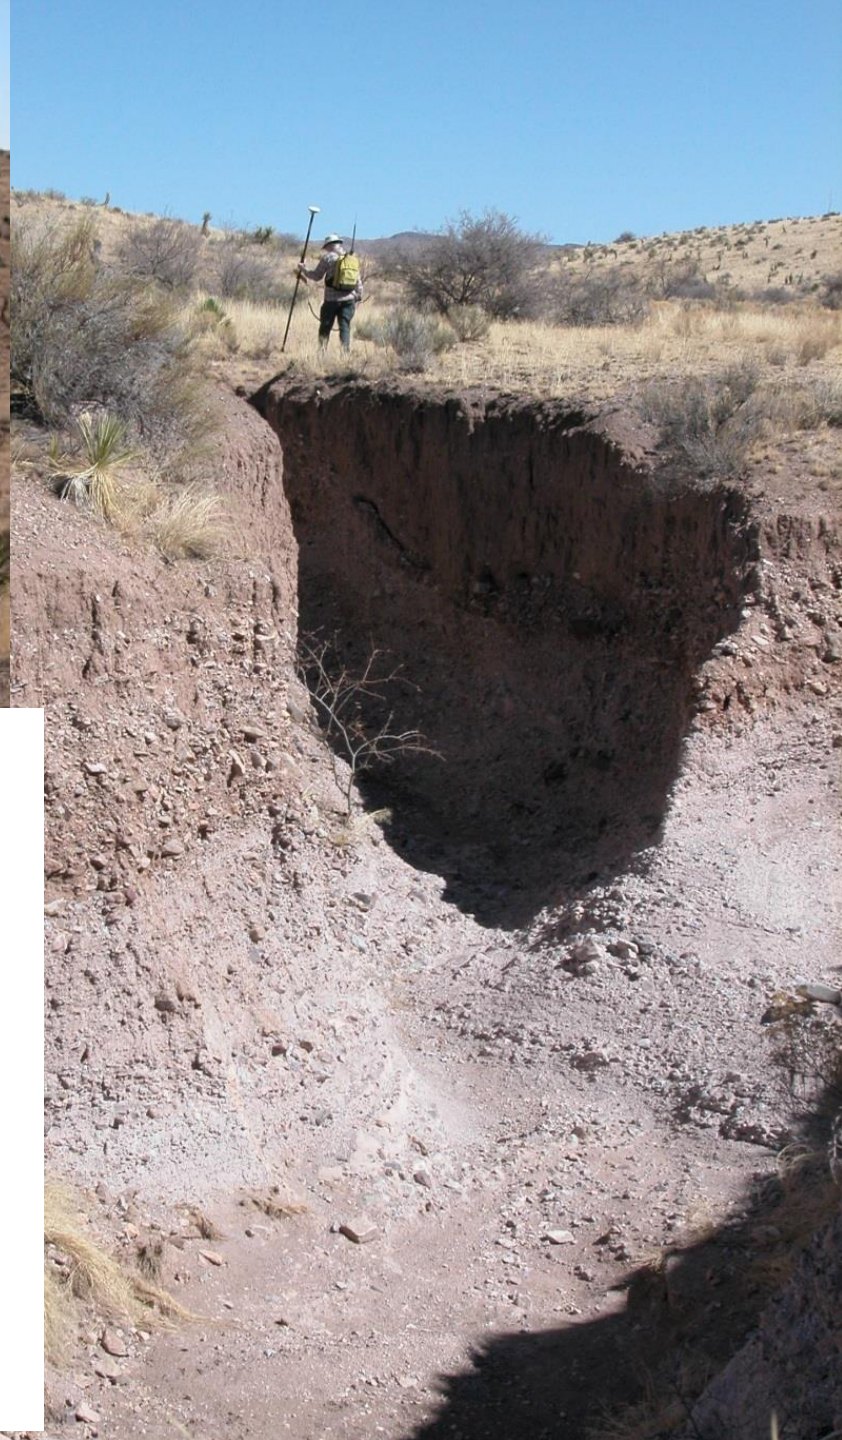
South Headcut

Headcut outline
[year]

- 2004
- 1981
- 1976
- 1973
- 1966
- 1935

Calculated flow path

- 2003

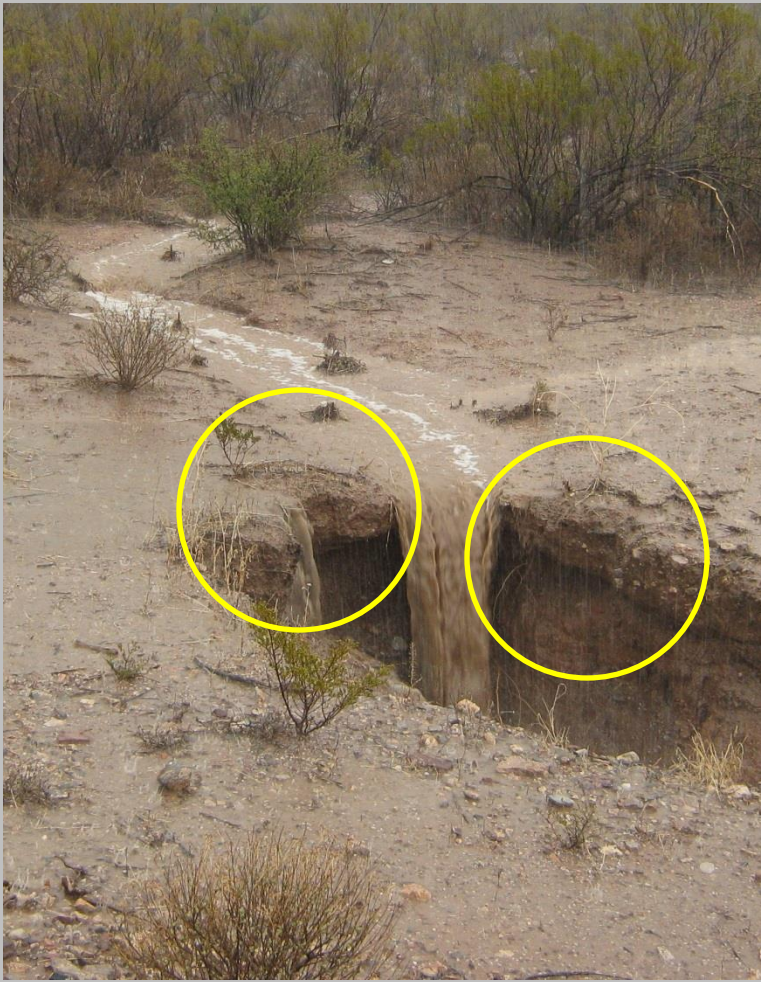
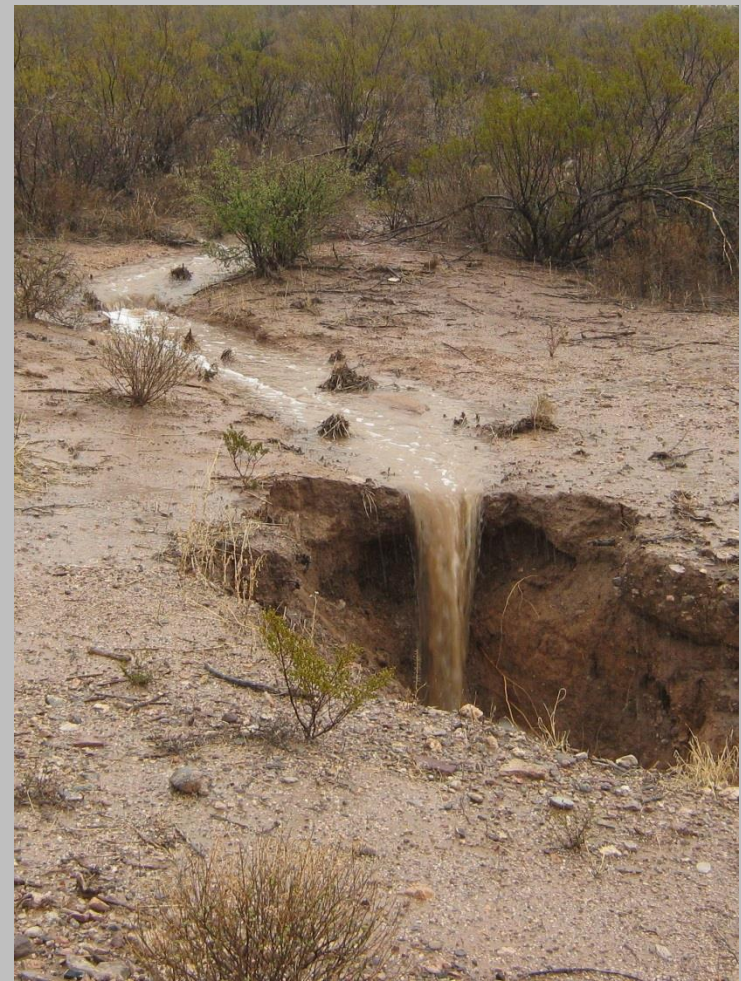
Evaluated all of the time-lapse sequences from 2012 through July 2014 and qualitatively described the dominant erosion processes:

- 0 no change observed
- 1 dry ravel and minor sediment grain movement
- 2 scour at channel headwall or channel banks
- 3 slumping or plunge pool erosion

Classified processes were evaluated against the hydrologic drivers:
rainfall, runoff, and change in water content (wetting or drying soil)

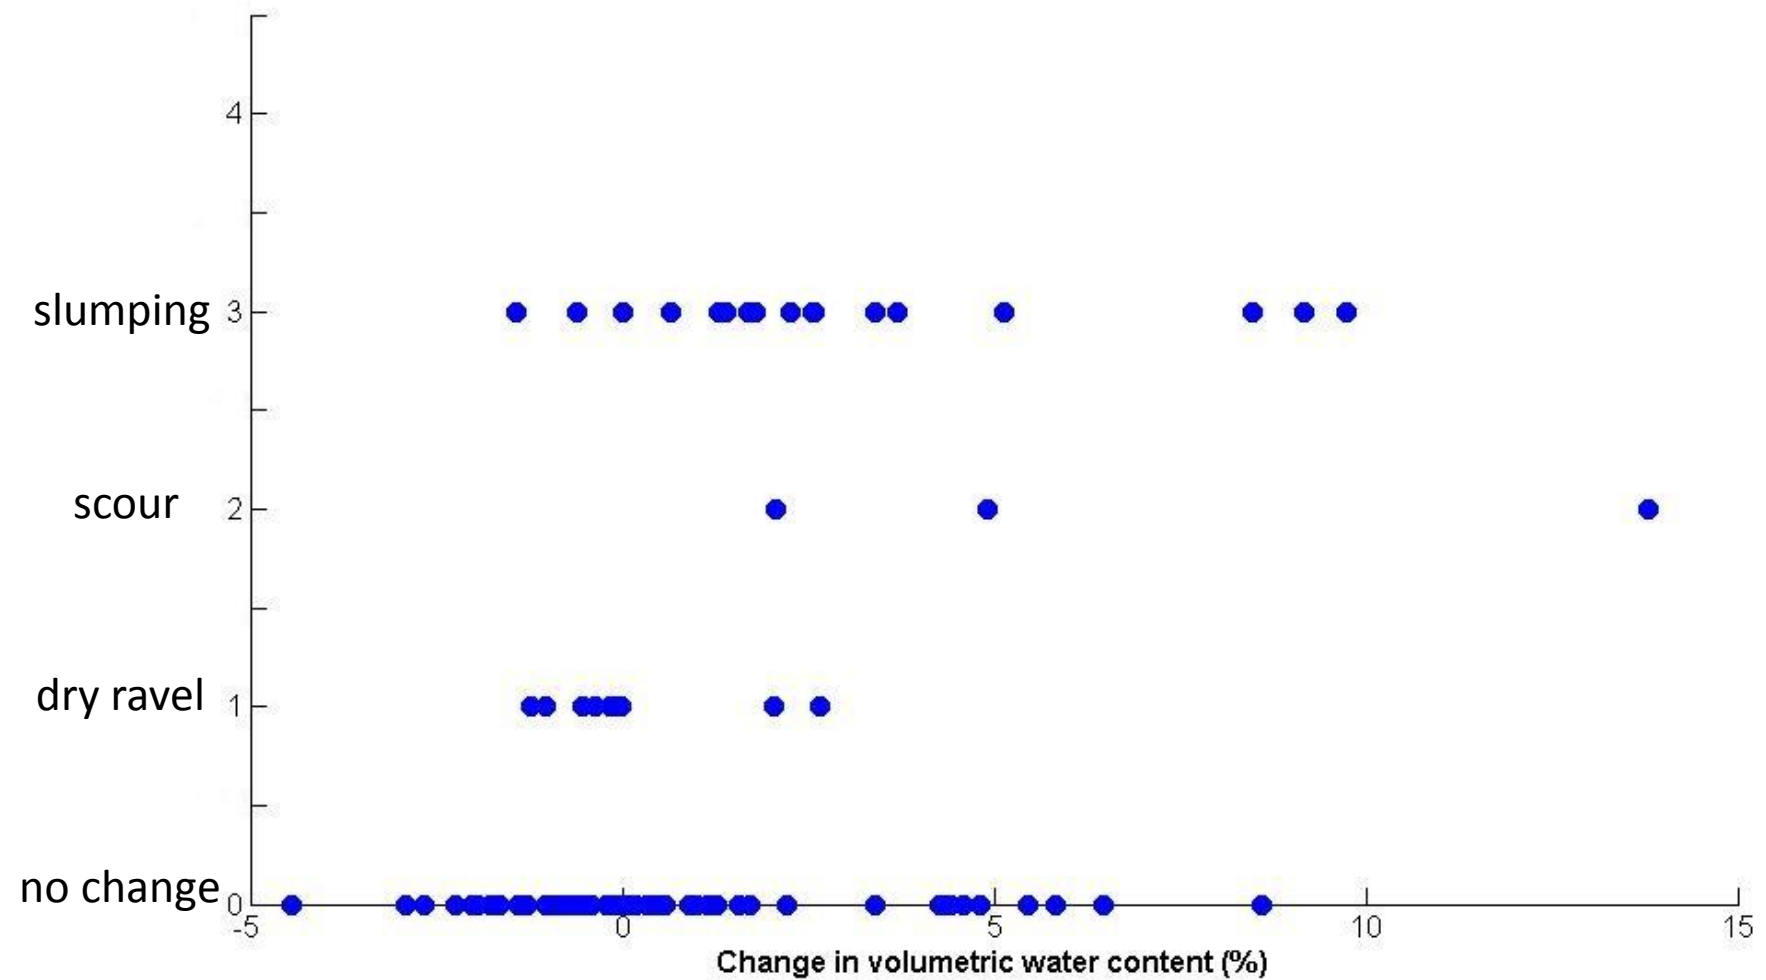
August 1, 2014
Video

But it happened at night!
In the dark!

- Rainfall was not remarkable
- Runoff was not remarkable
- Change in water content was not remarkable

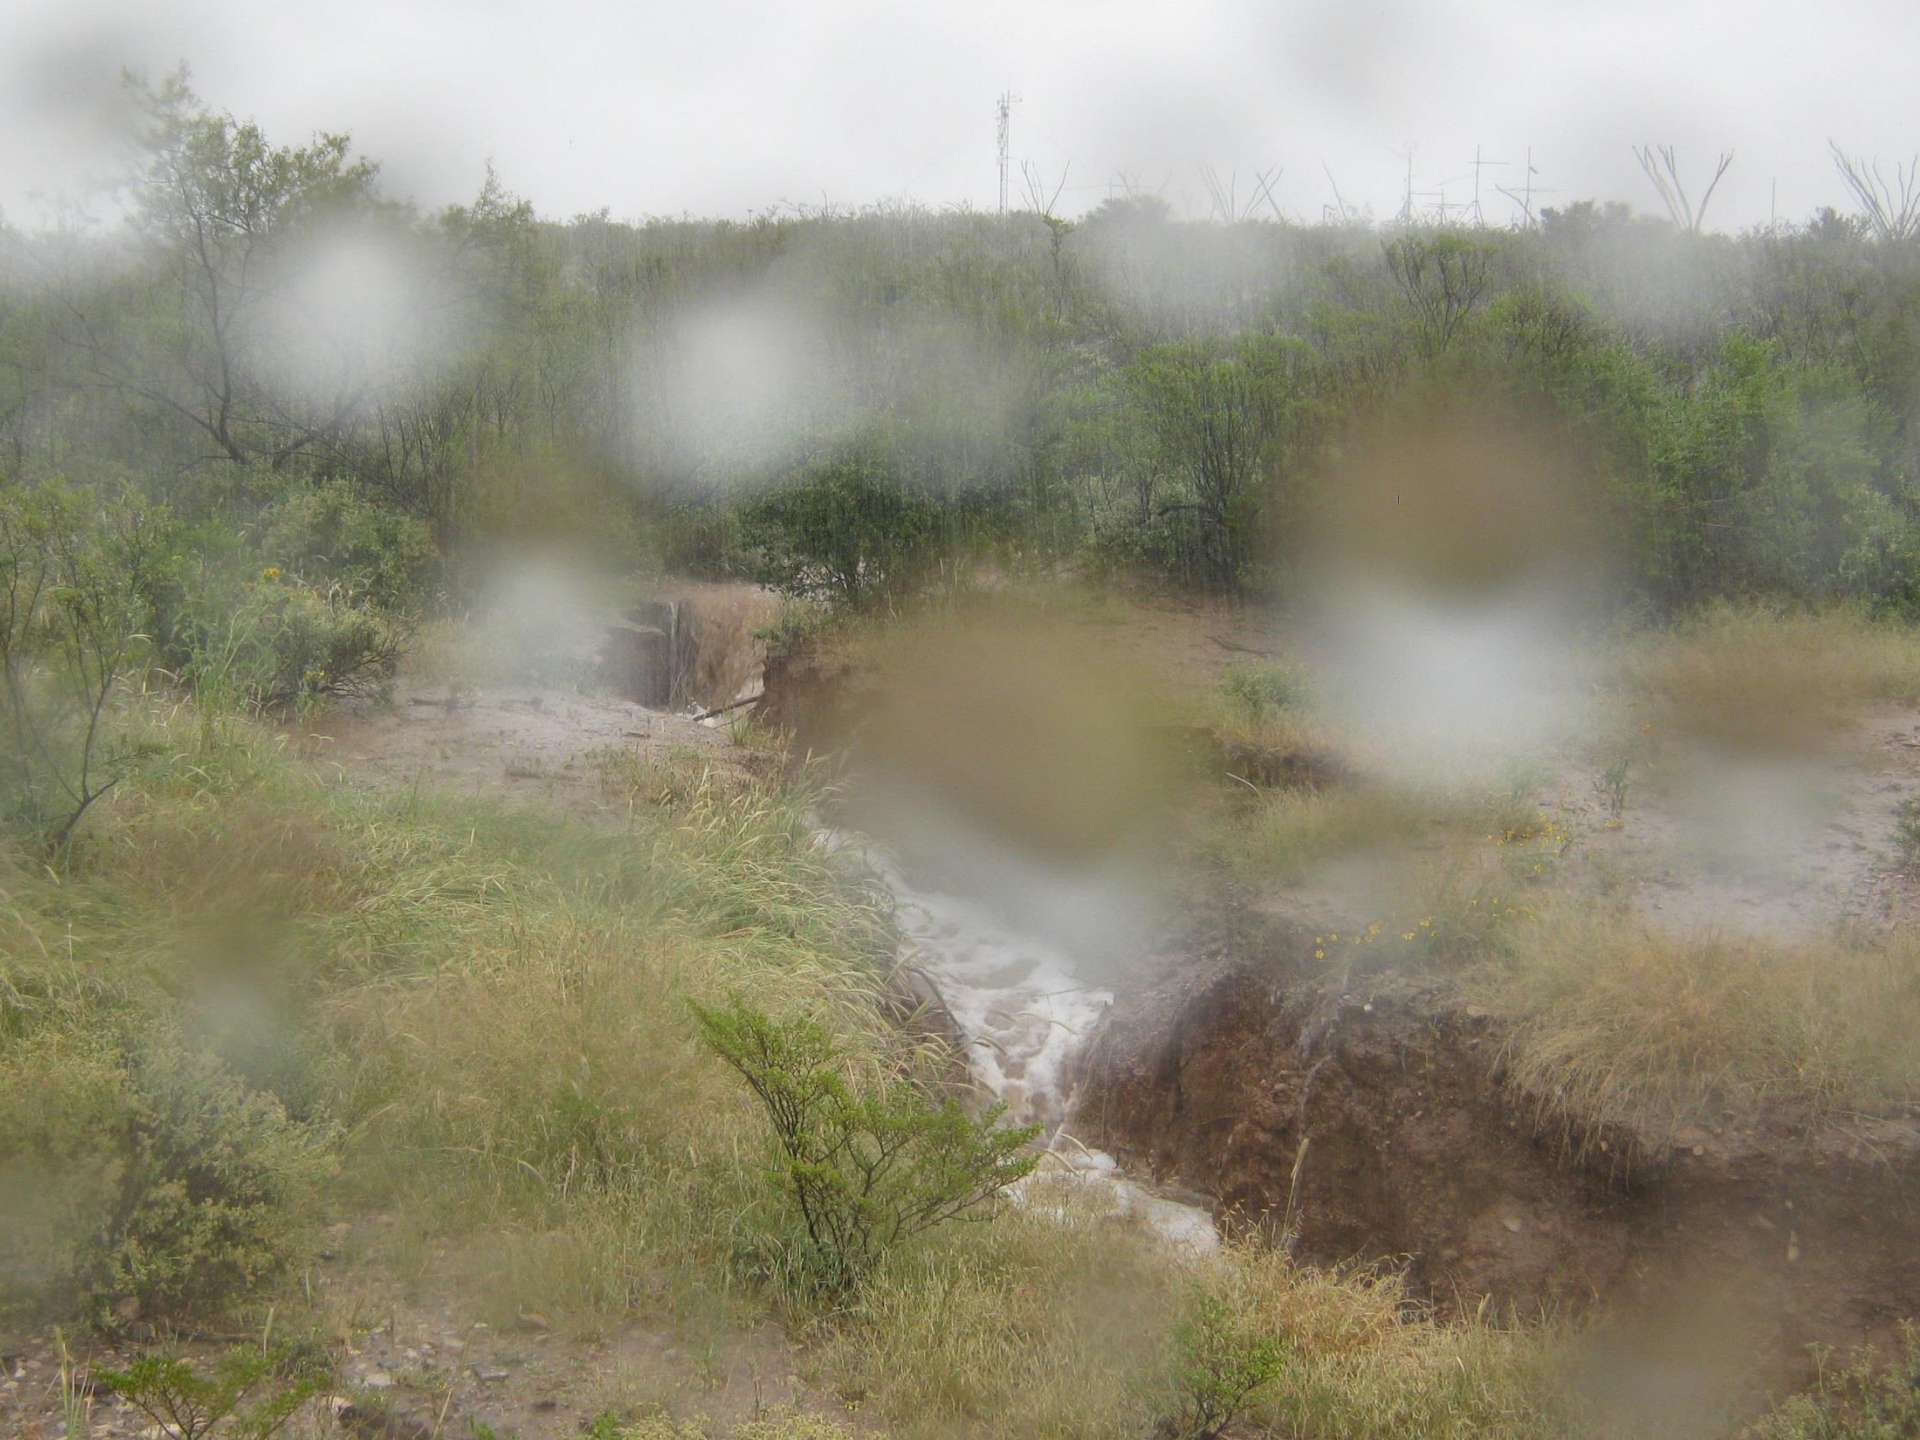
Destructive piping on an abandoned farm near Benson, Arizona.
